Module 1: Introduction of Building Pathology, Diagnosis, Prognosis and Appraisal; Initial Case Studies; and Types of Deterioration of Structural Components.

A lecture by Ir. Jeffery Pirah

Exercise 3: Diagnosis & Prognosis - Case Study on Defects and Deteriorations SMK Ranau, Ranau, Sabah (Group 1)

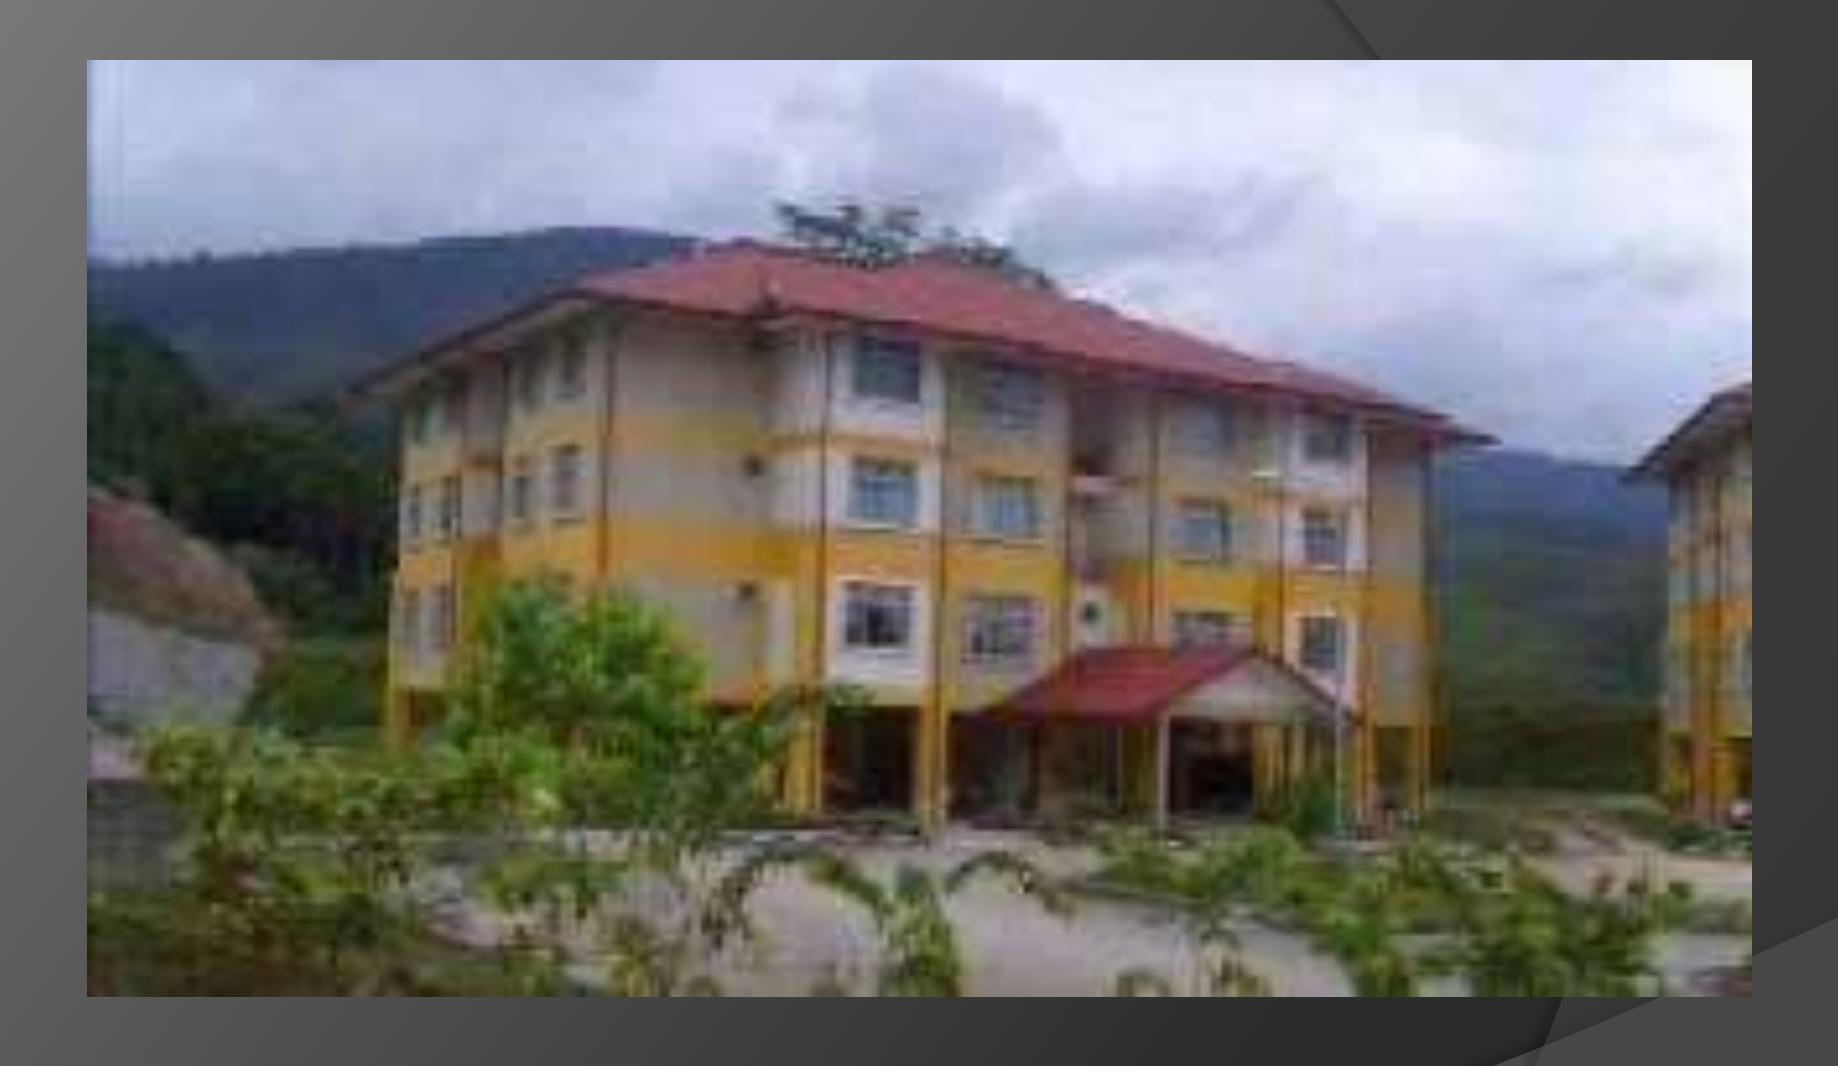
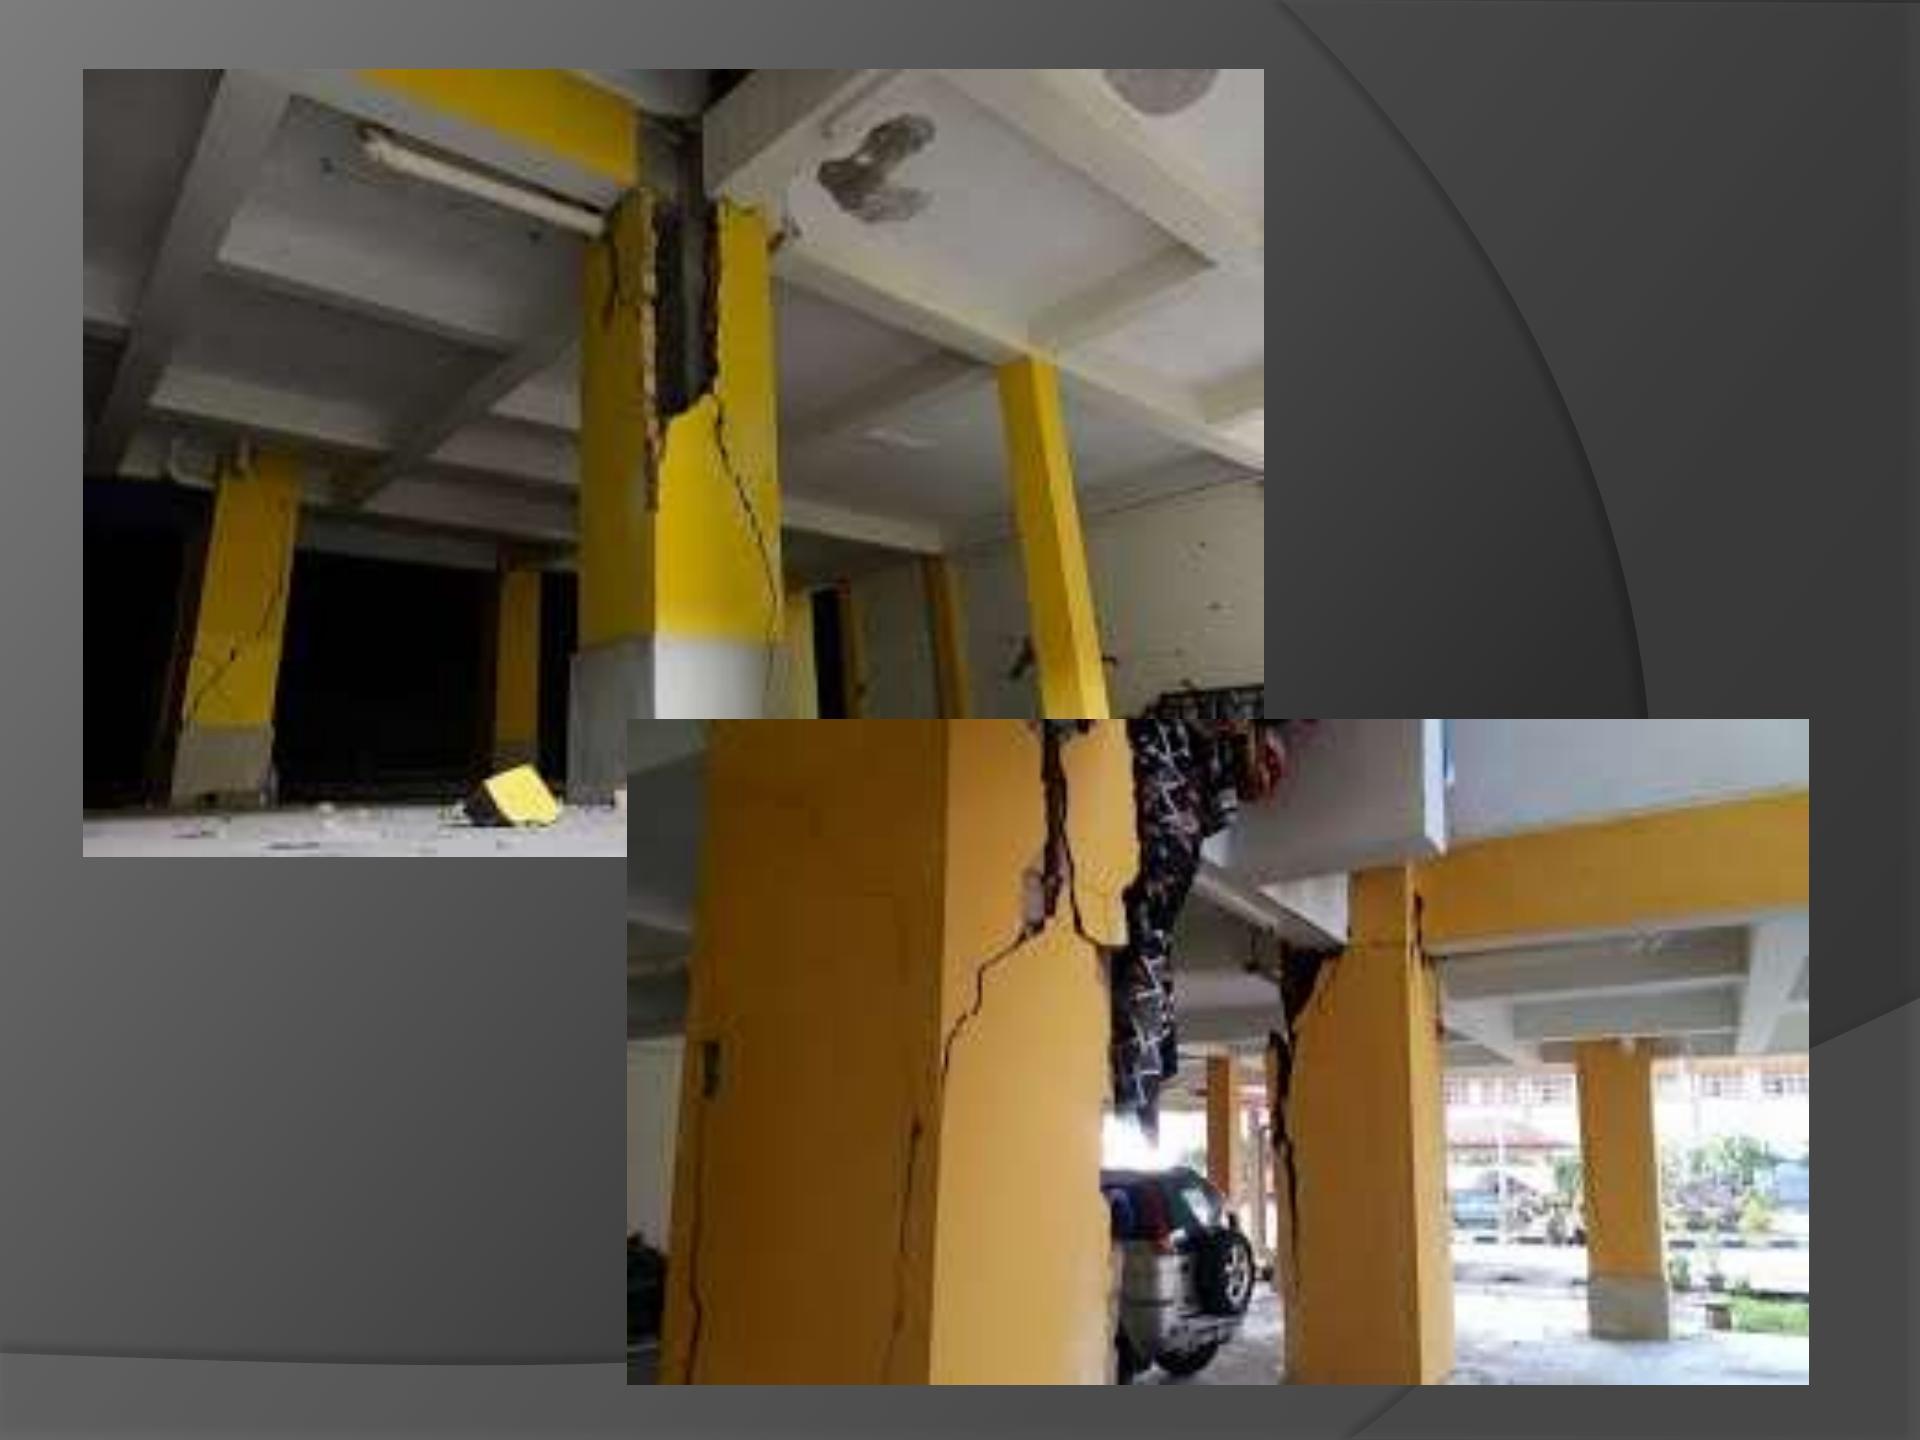
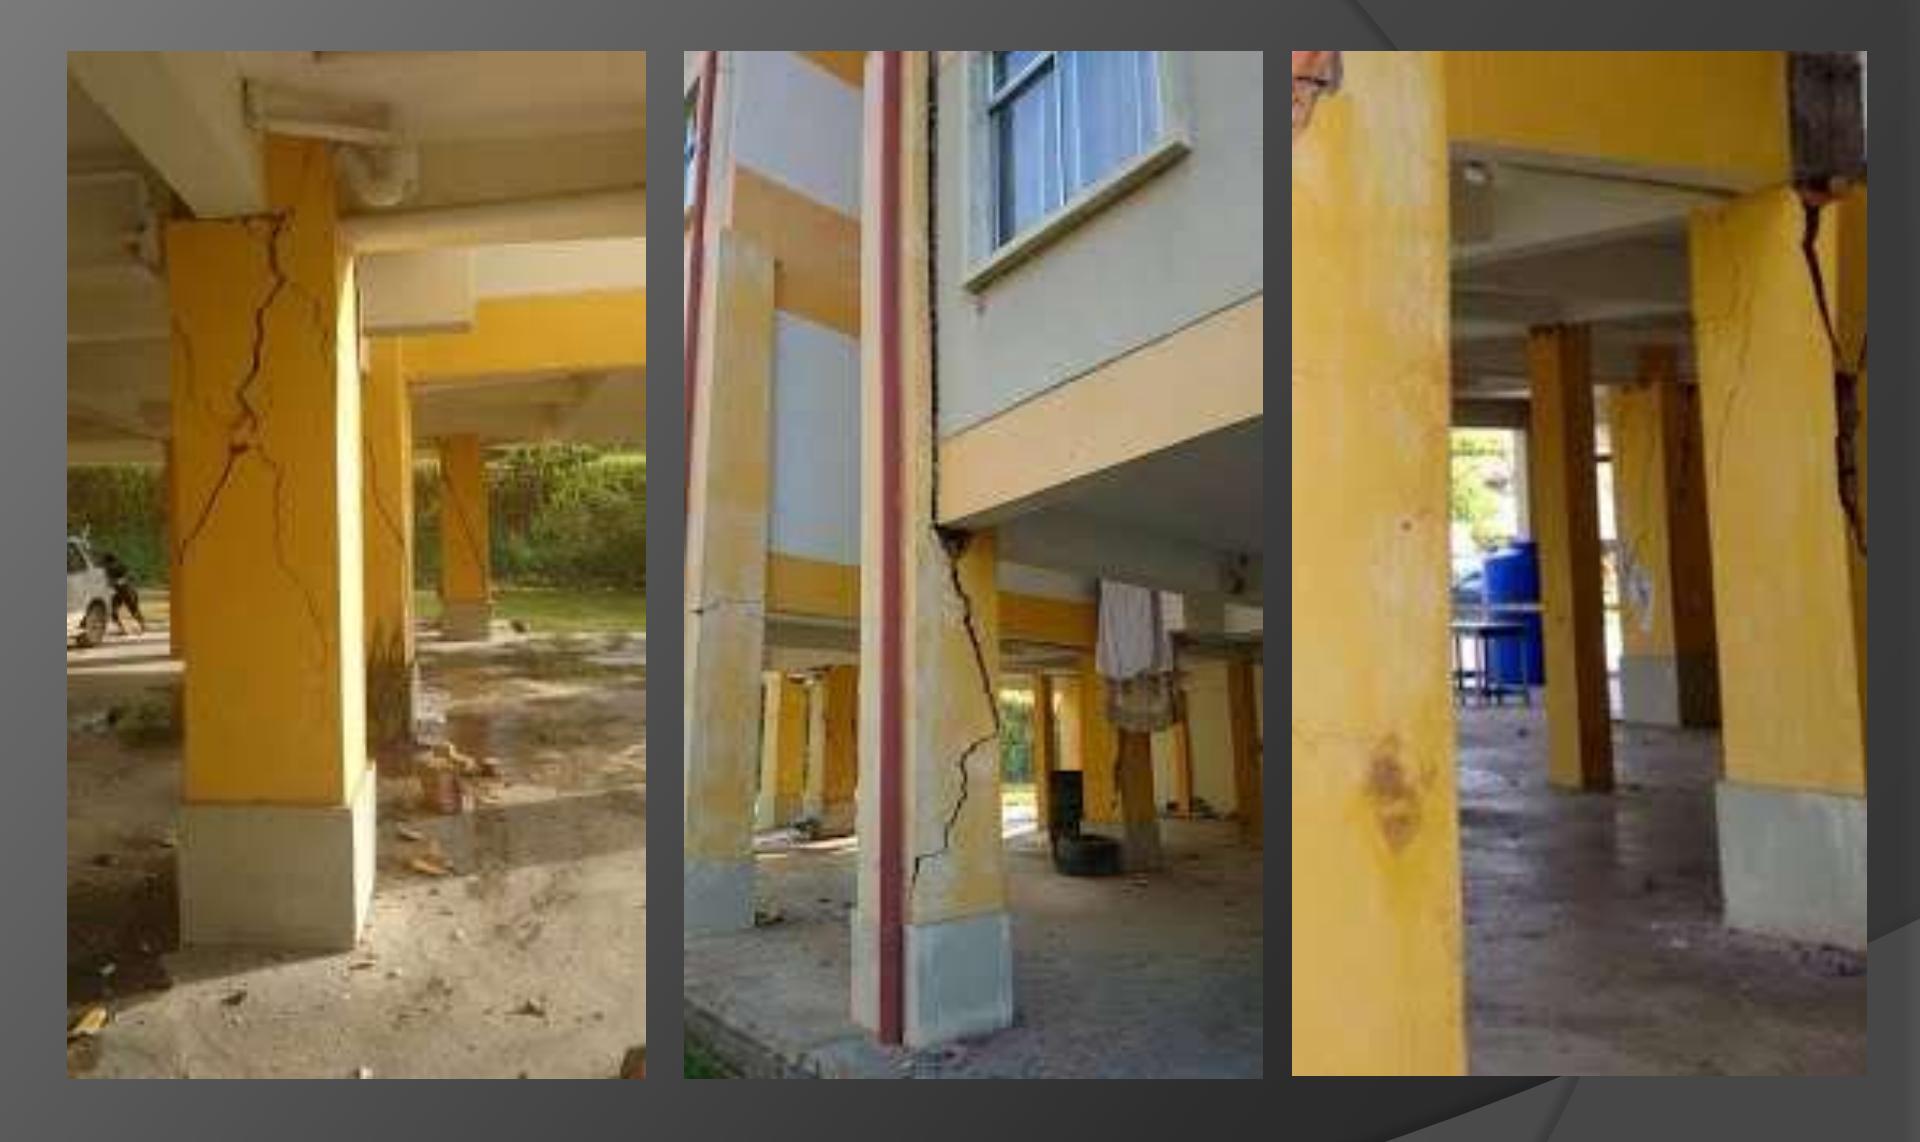
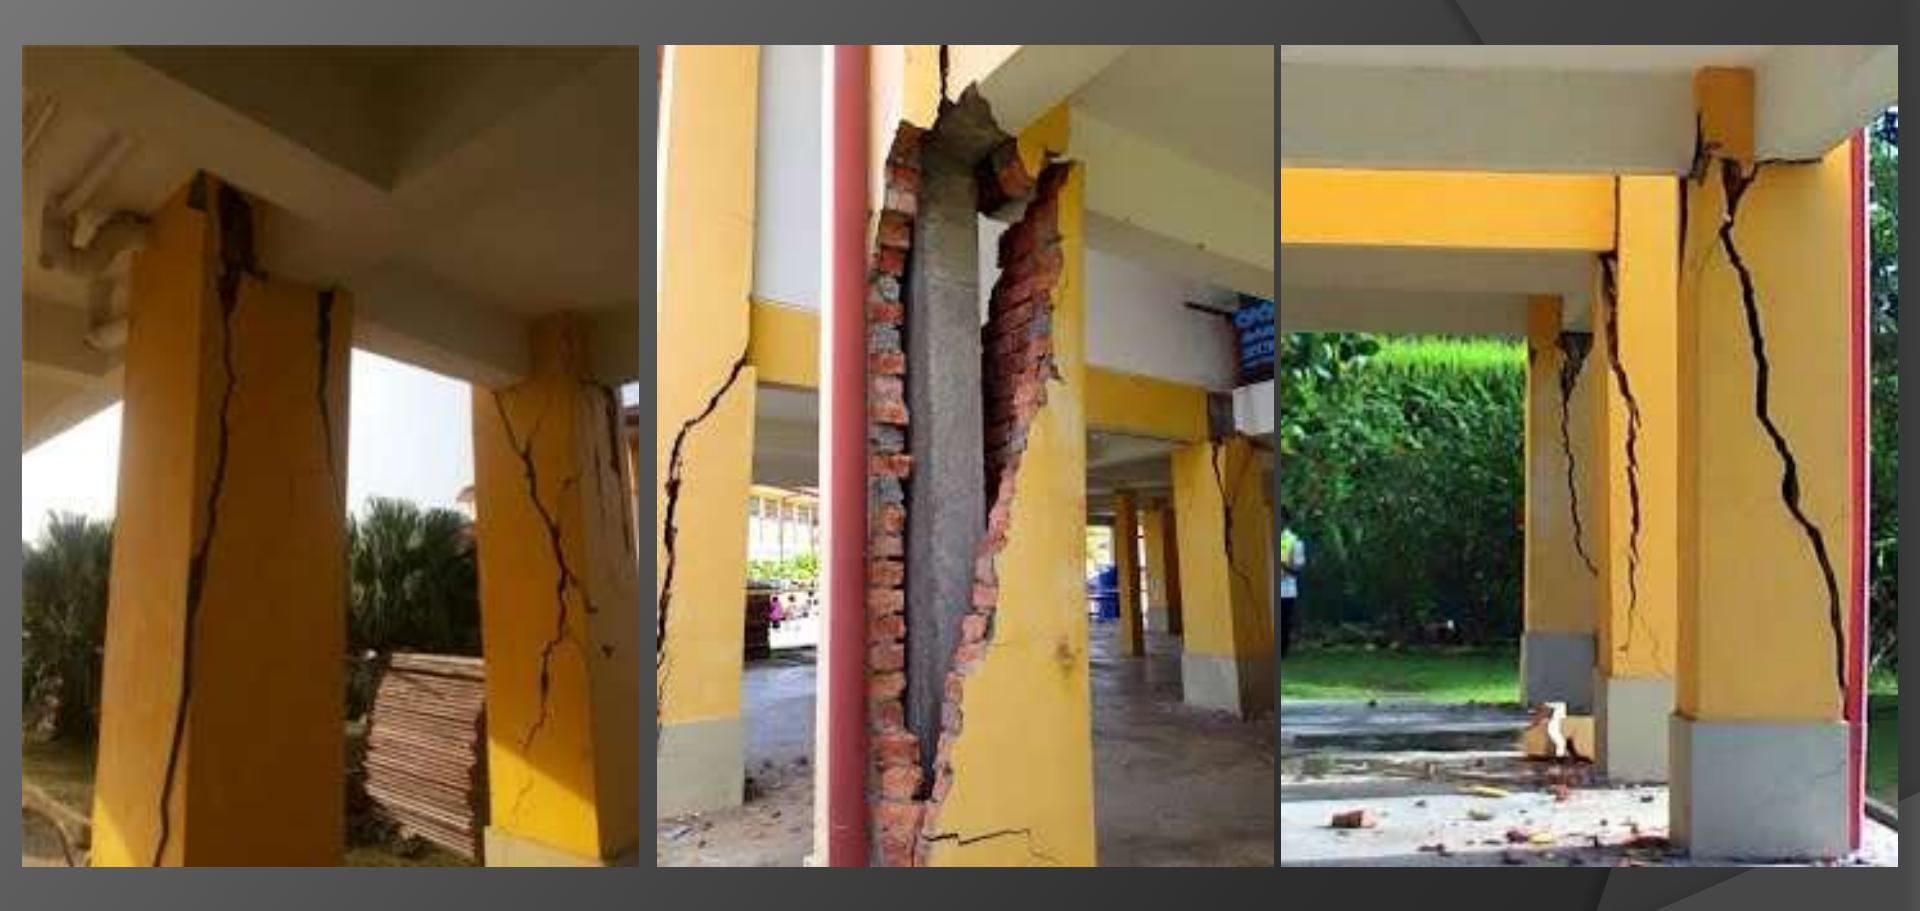
•Based on the provided photos, the main issue is the cracking of the brick cladding. This is non-structural failure.

•The exposed reinforced concrete column looks tiny however no visible crack can be seen.

•Apart from the column, the other structural members such as the beam, does not shows any sign of failure or deterioration.

•Similarly, those columns to ground floor slab connection does not show any sign of punching shear, therefore no significant delamination occurred.

•The connection at the beam and column does not show any failure which indicates that the structure resisted and remained in equilibrium with the high capacity of the shear reinforcement.

•There is no broken window and this suggested that, the force reacted toward the building is relatively dampened.

The structure is quite robust and does not succumbed to any deterioration or failure.

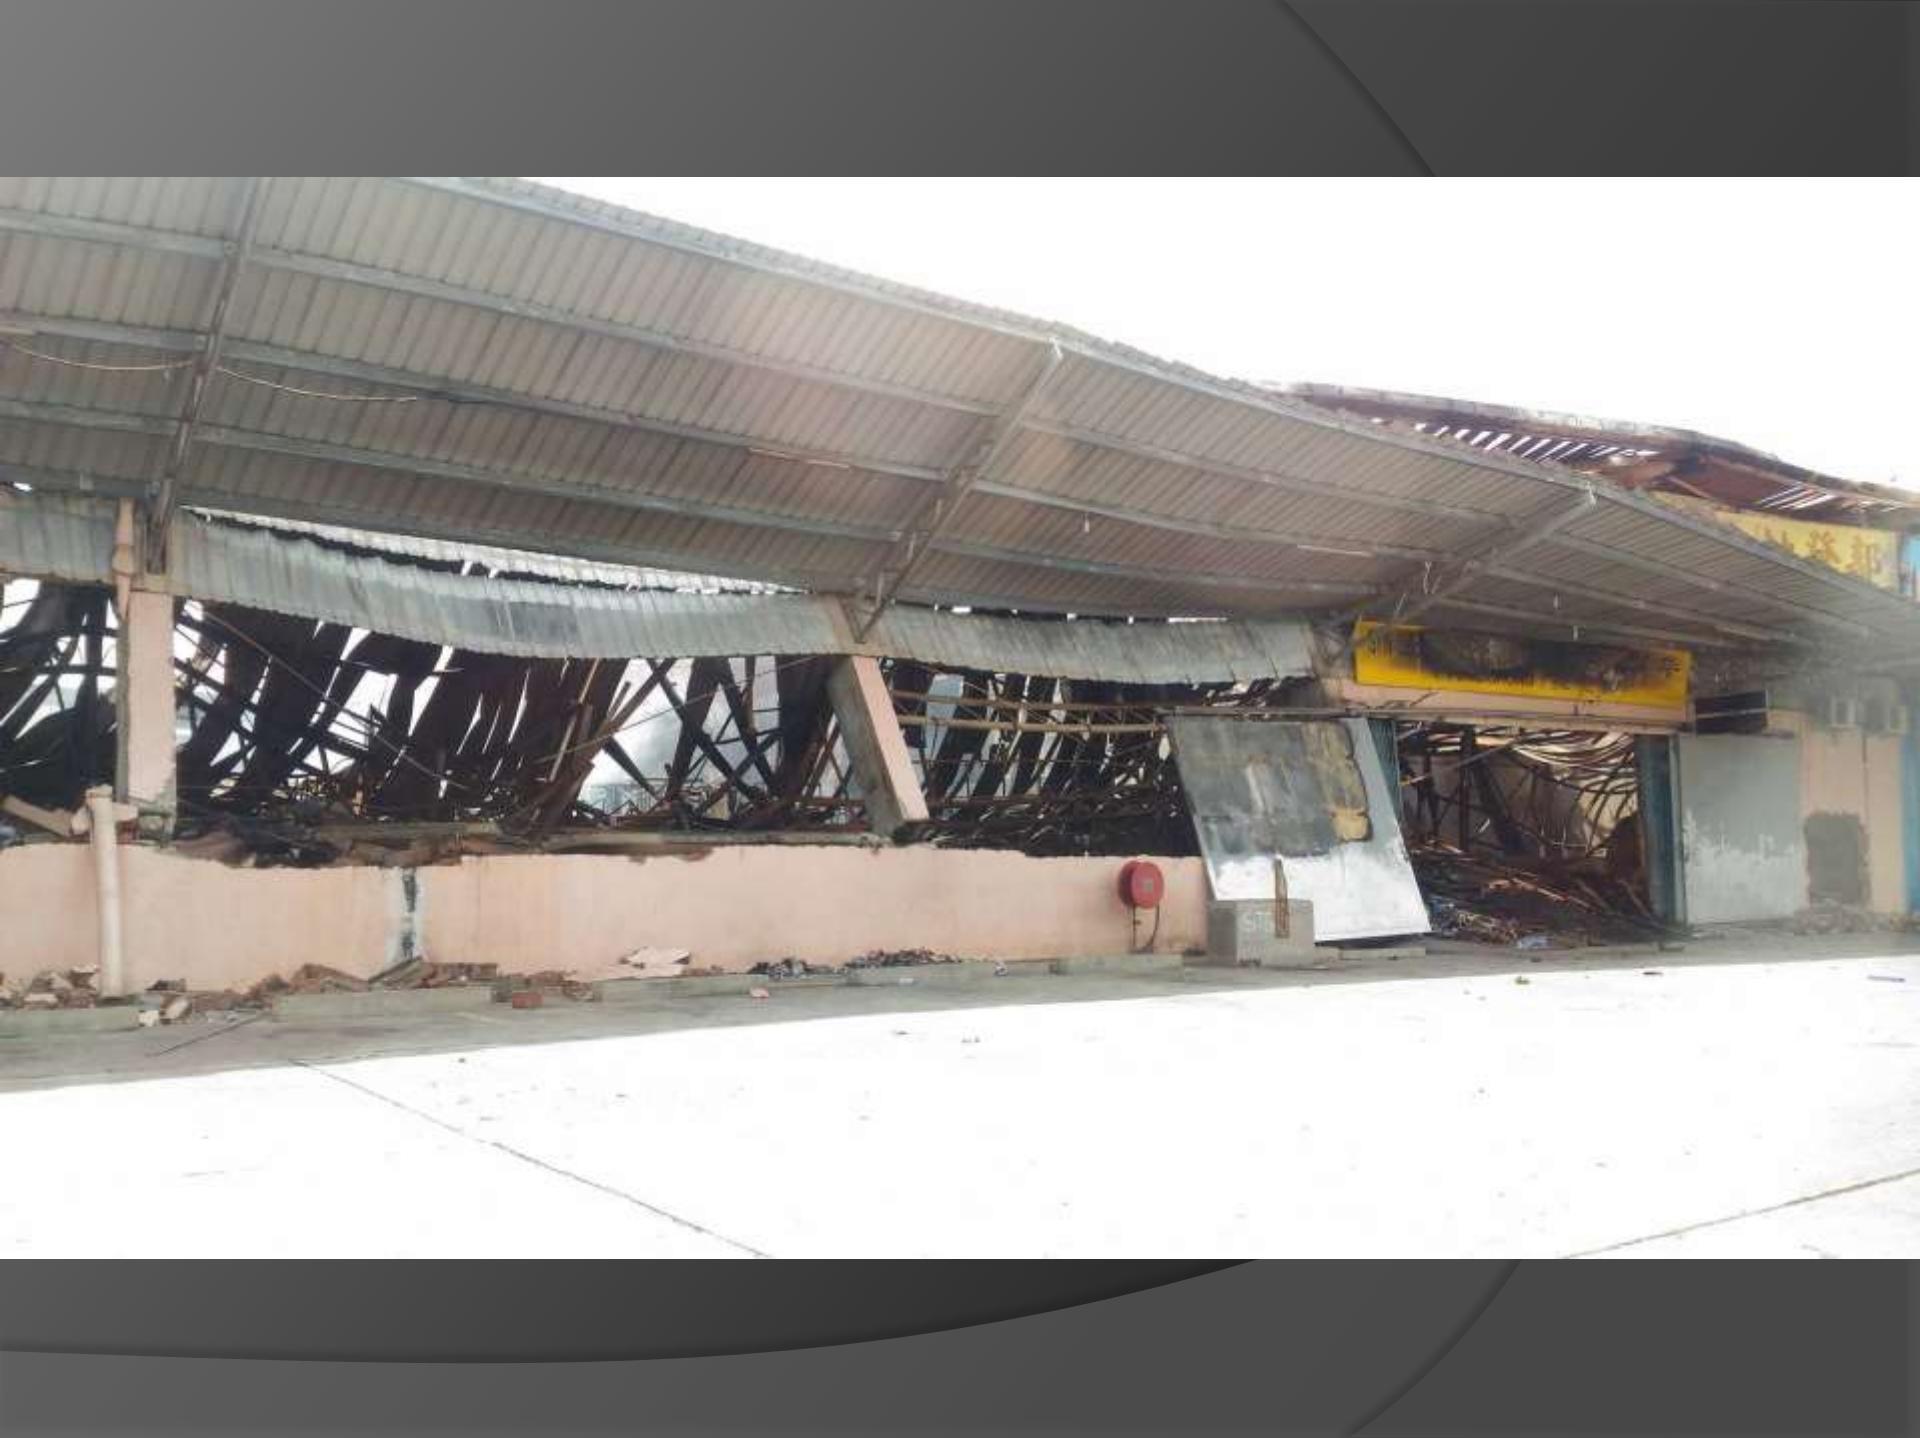
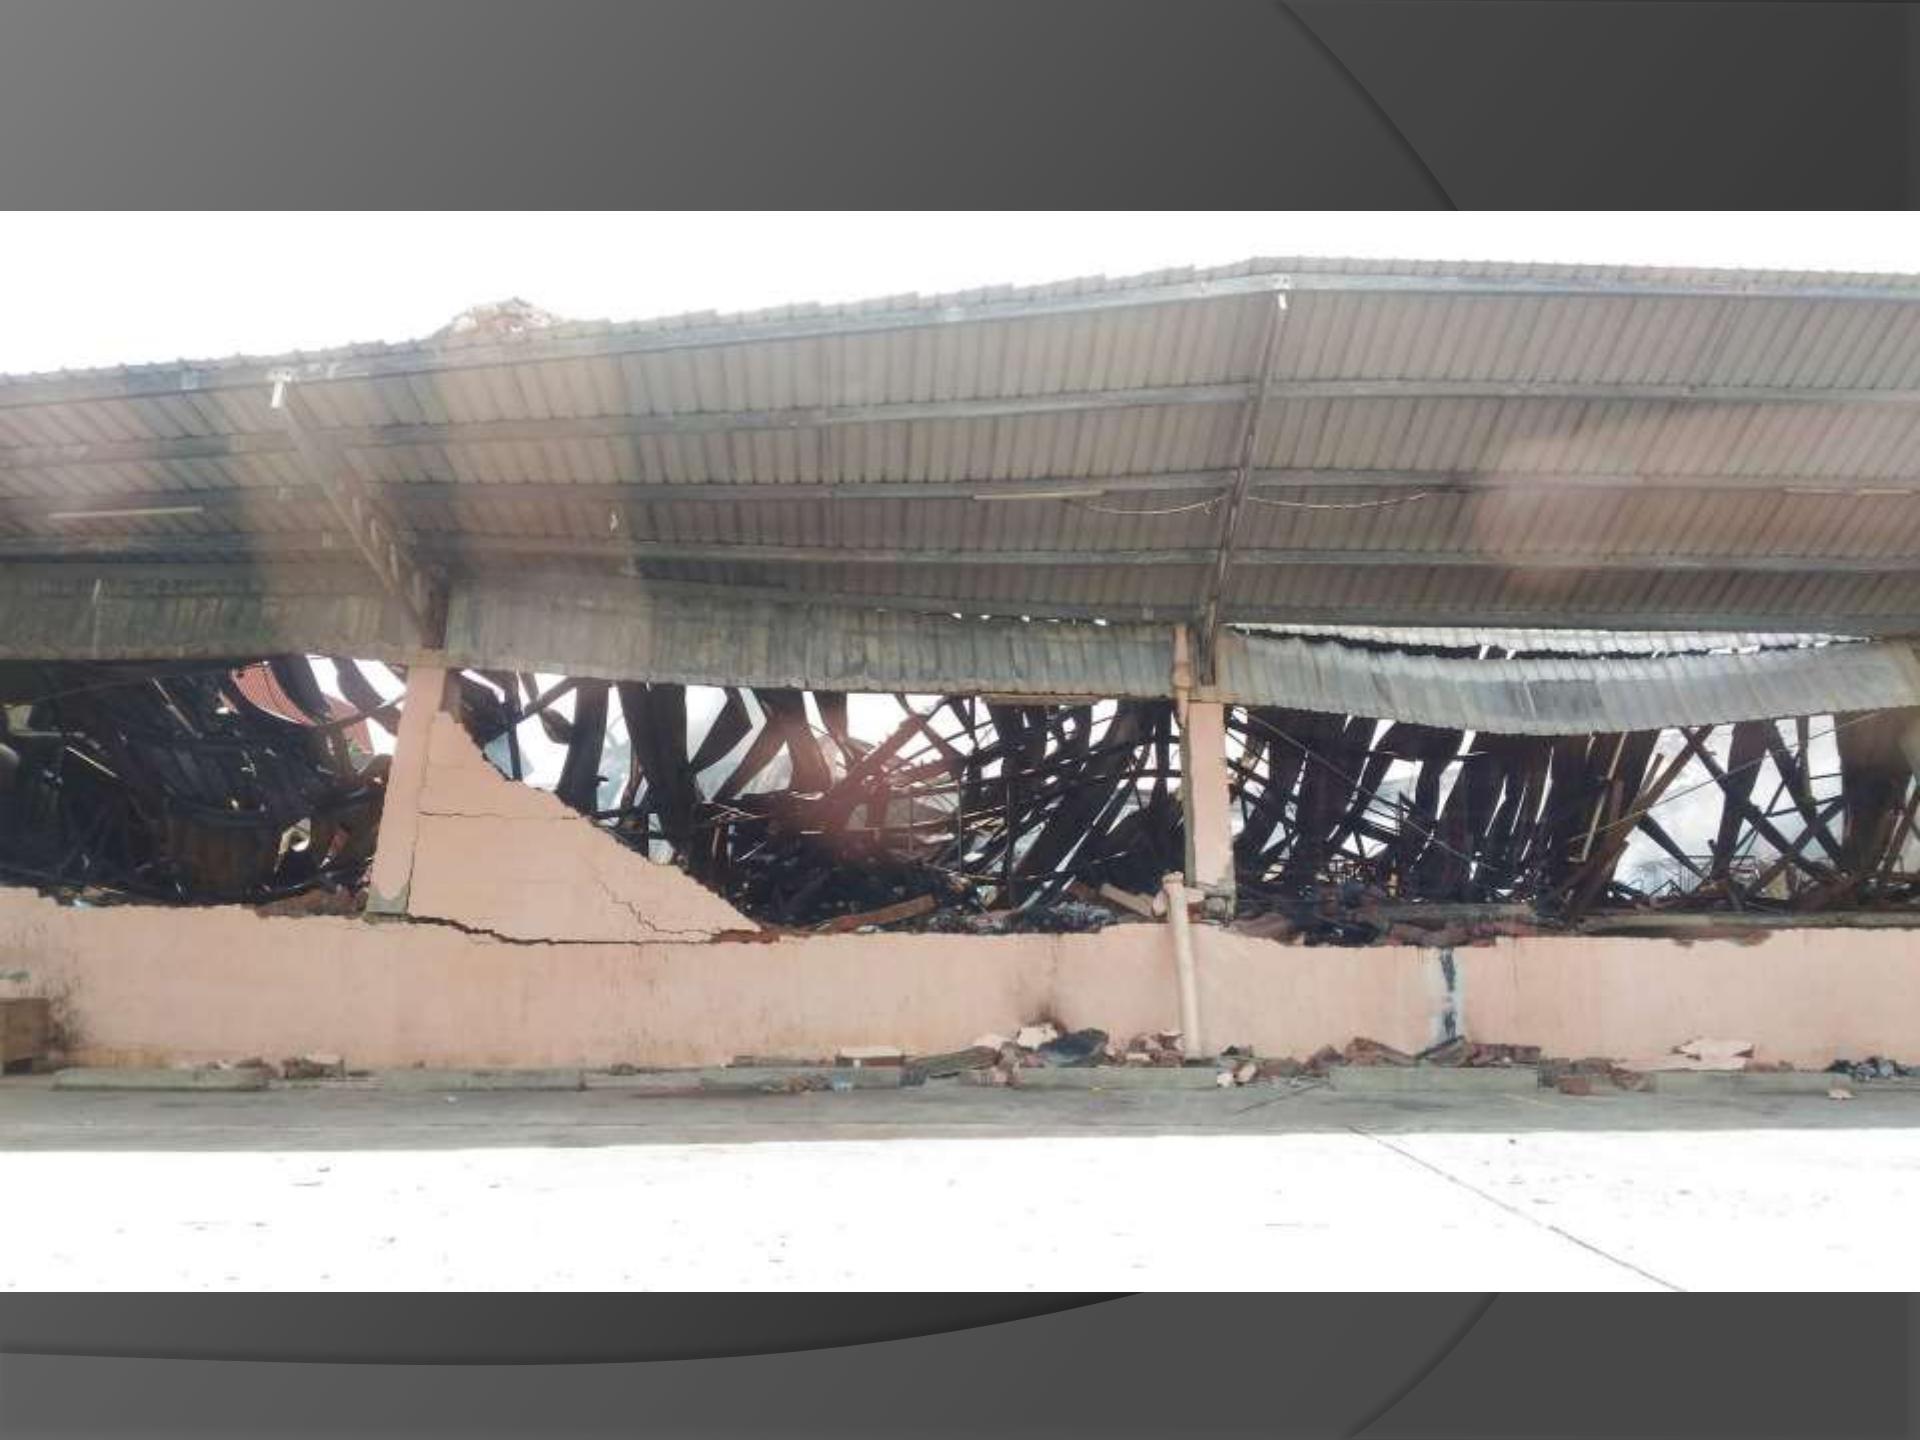
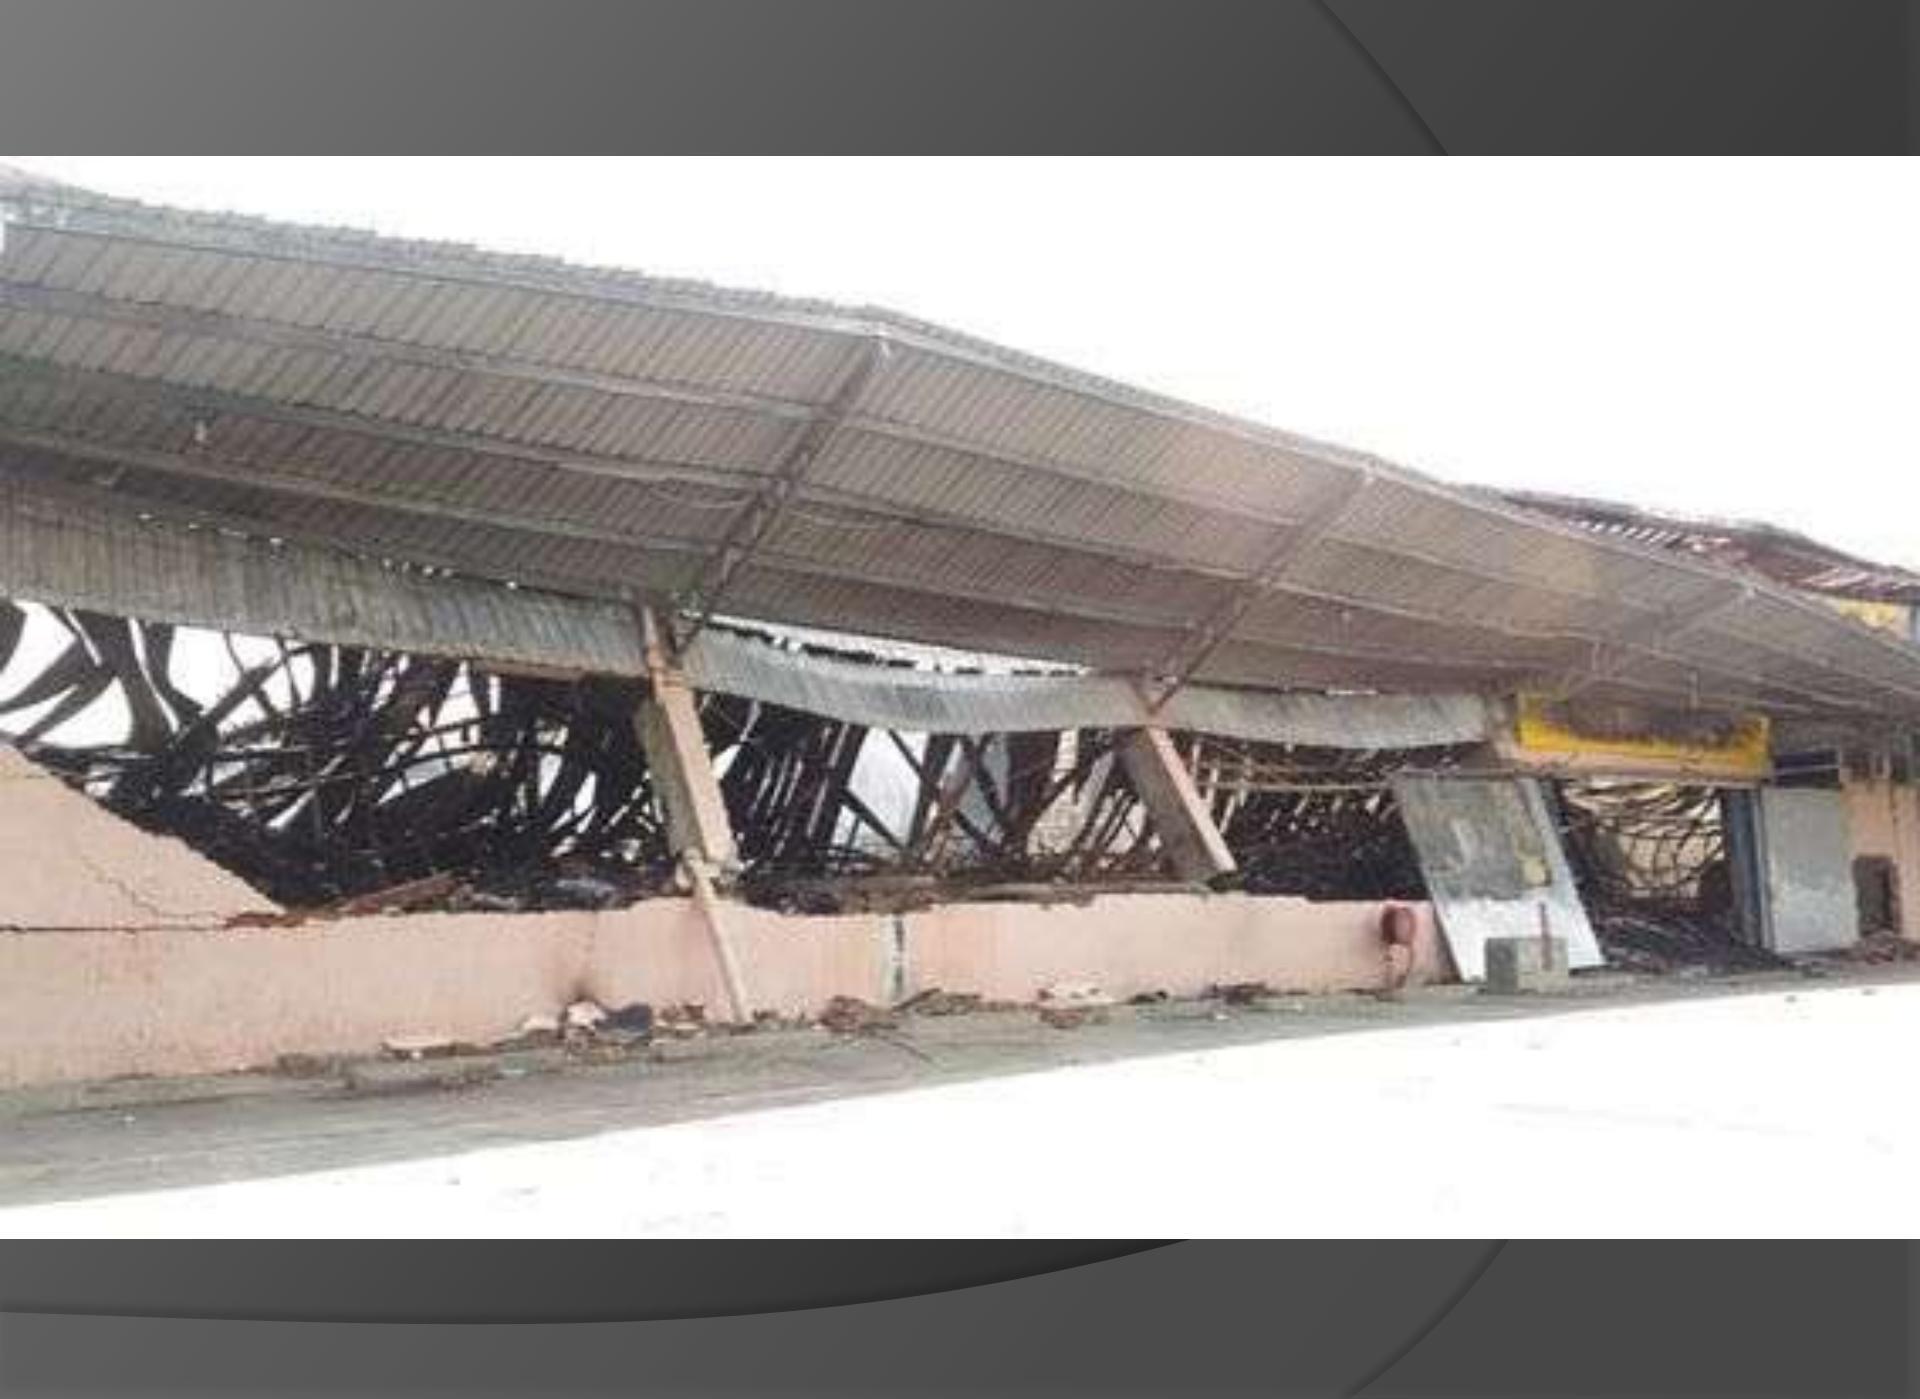
•First, the fire is most likely to be of medium intensity. Although the steel structures buckled, it is less likely due to high intensity fire. The buckling of the structure is most likely due to the self weight and series of design issues. From the photo, the main truss was not designed appropriately where the webs are too small to withstand the desired capacity in order to function optimally. Another sign of medium intensity fire is the carbon staining around steel structures.

•Second, the collapsed of this building is due to inappropriate extension work(s). The extension did not consider the design capacity where the unrestrained columns failed when encountered moment force when the main truss bolted to the column rotated with downward force.

•Third, with careful eyes, you can see the columns and stiffeners on the second/third photo. The main reinforcements for the column is presumed to be smaller than anticipated under such loading. It has the same size with the nominal link or stirrups.

•Fourth, with careful eyes, the failure of this building is due to method of construction for these columns. It is likely that there is a cold joint for columns at the height of 750mm - 900mm. Untreated cold joint is dangerous when it is the area which initiate tensile stress under multiple loadings

Those structural members which are destroyed are not fit for structural purposes. No steel structural members are salvageable for reconstruction. It is assumed that 90% of the structural members are damaged.

We reckon that this building should be written off, demolished and a new building should be erected by owner if there is an intend to operate in the nearest future. Exercise 3: Diagnosis & Prognosis - Case Study on Defects, Deteriorations and Failure Answer Tanjung Bungah, Pulau Pinang (Group 3)
