Module 1: Introduction of Building Pathology, Diagnosis, Prognosis and Appraisal; Initial Case Studies; and Types of Deterioration of Structural Components.

A lecture by Ir. Jeffery Pirah

Exercise 3: Diagnosis & Prognosis - Case Study on Defects and Deteriorations SMK Ranau, Ranau, Sabah (Group 1)

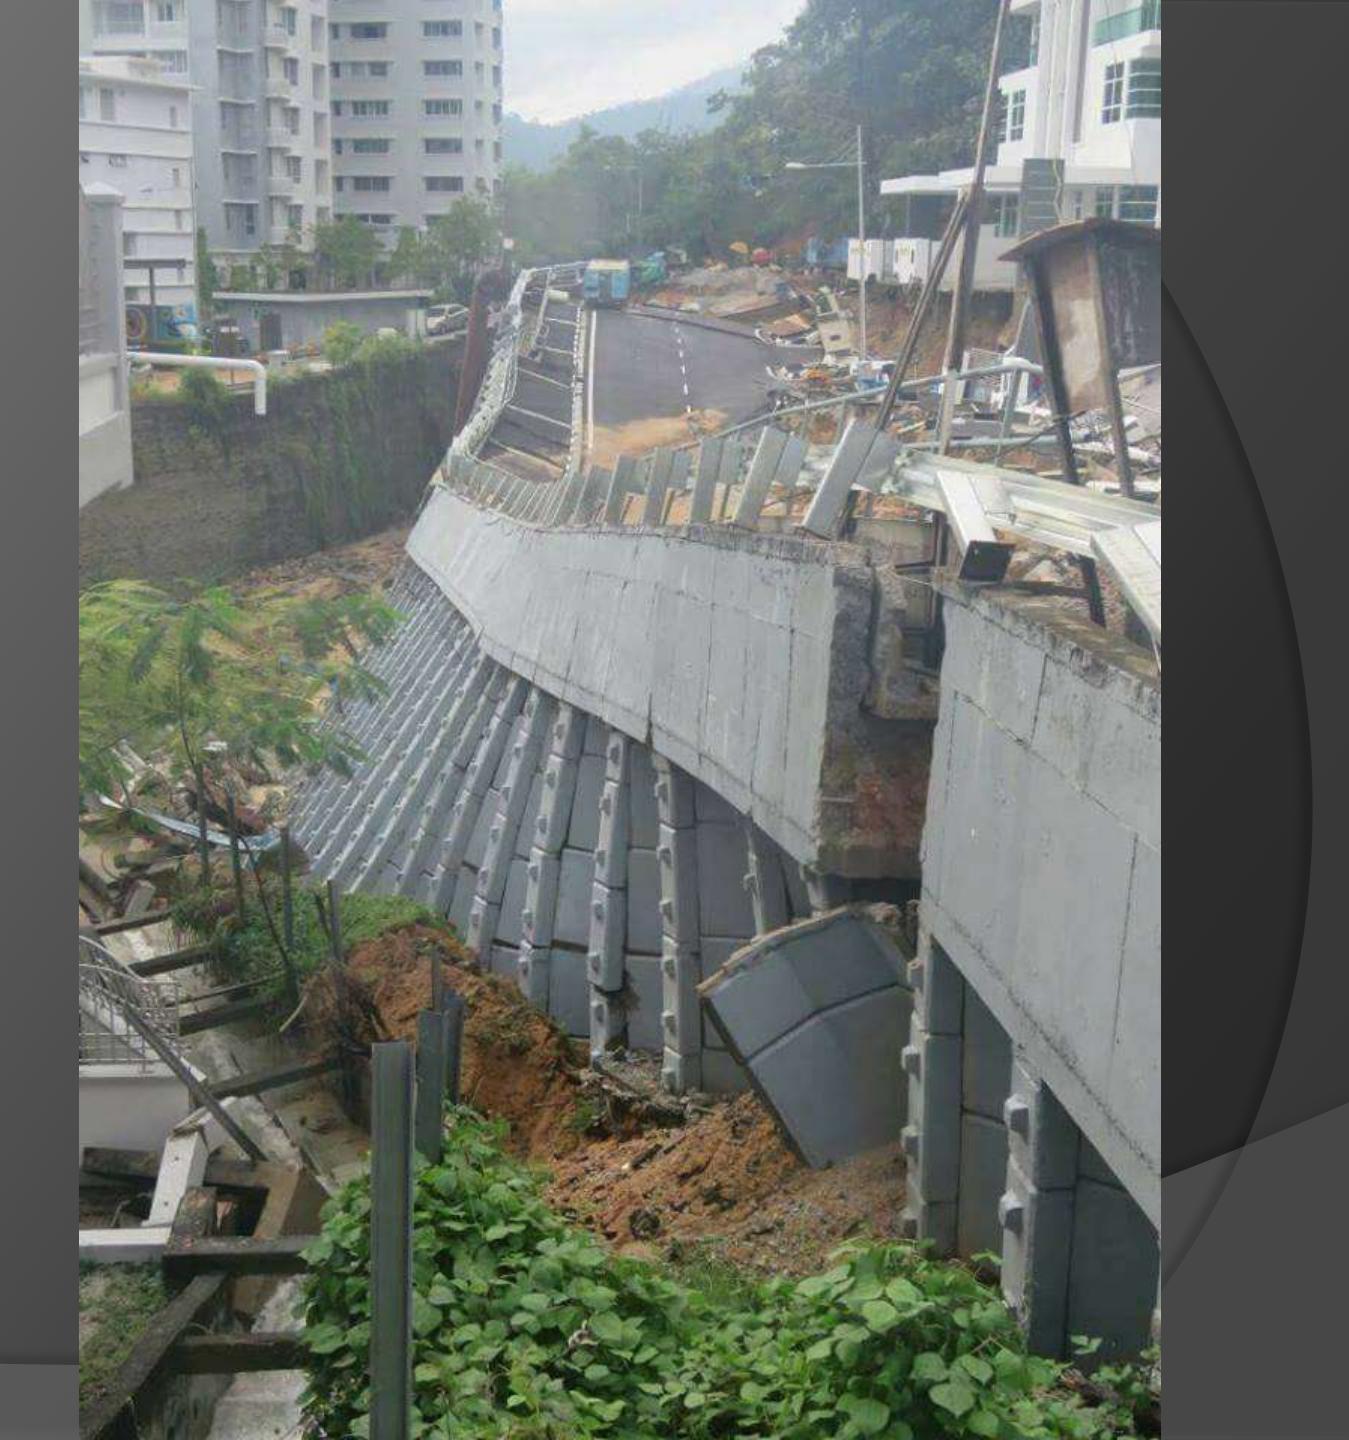
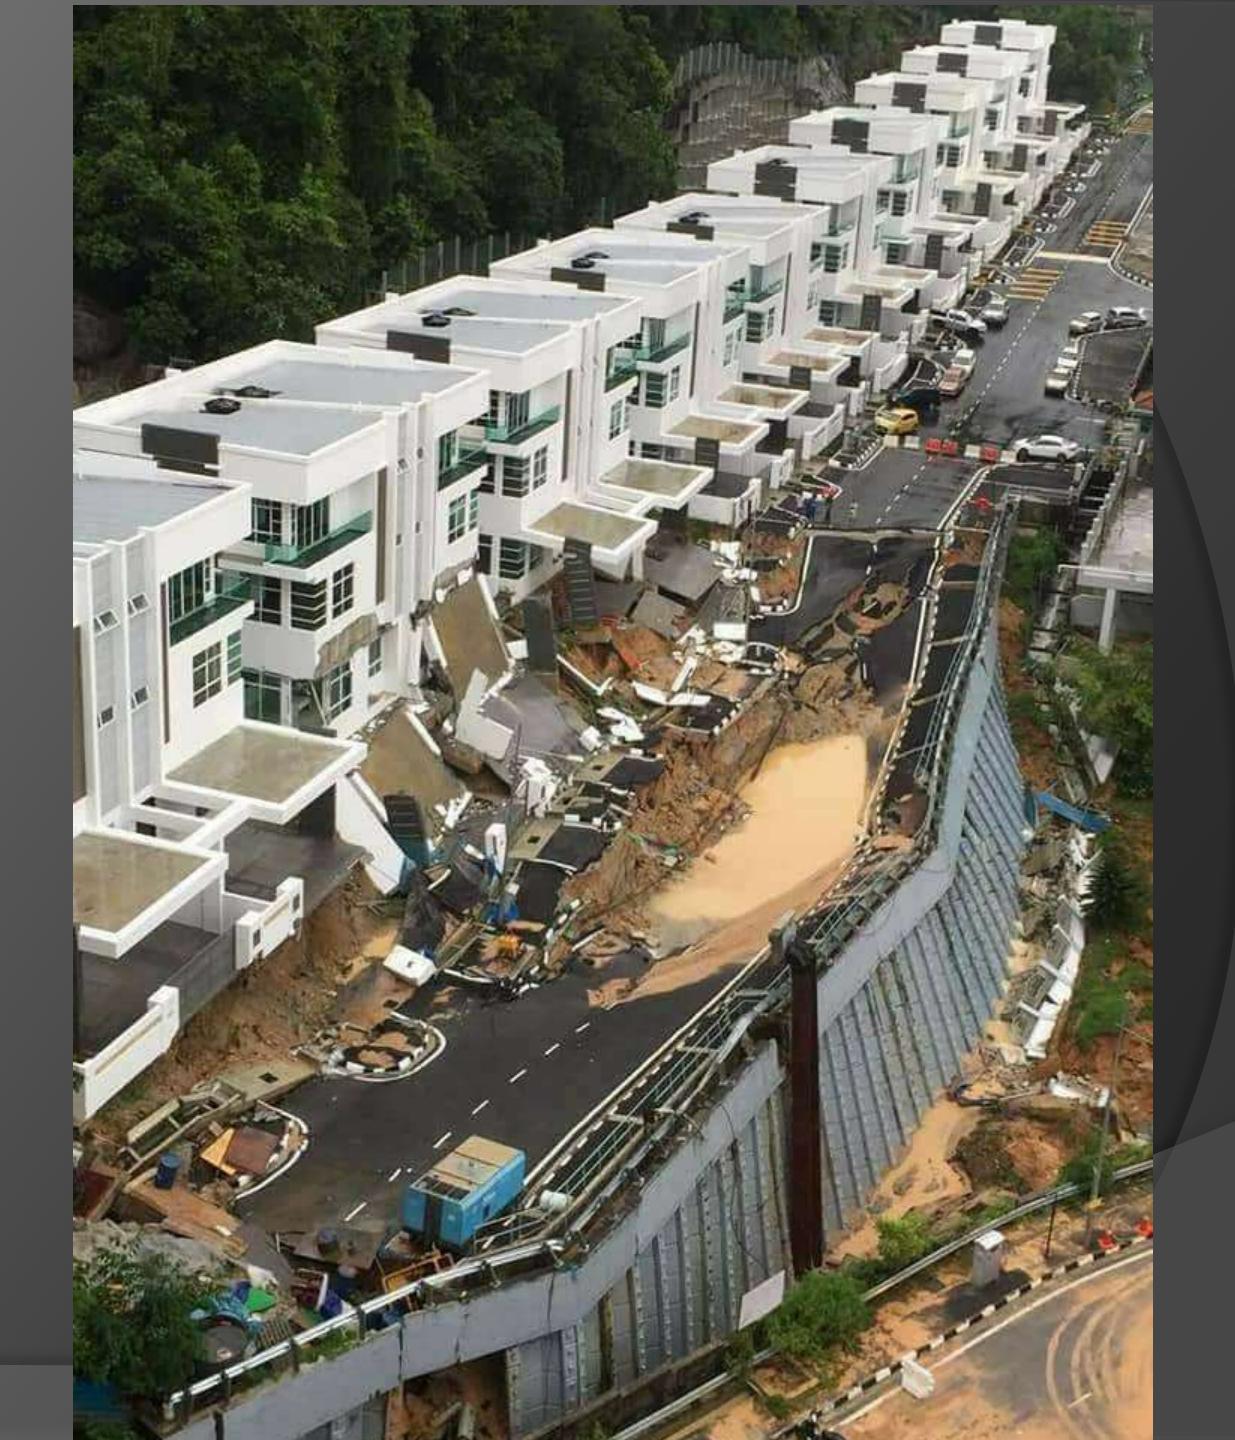
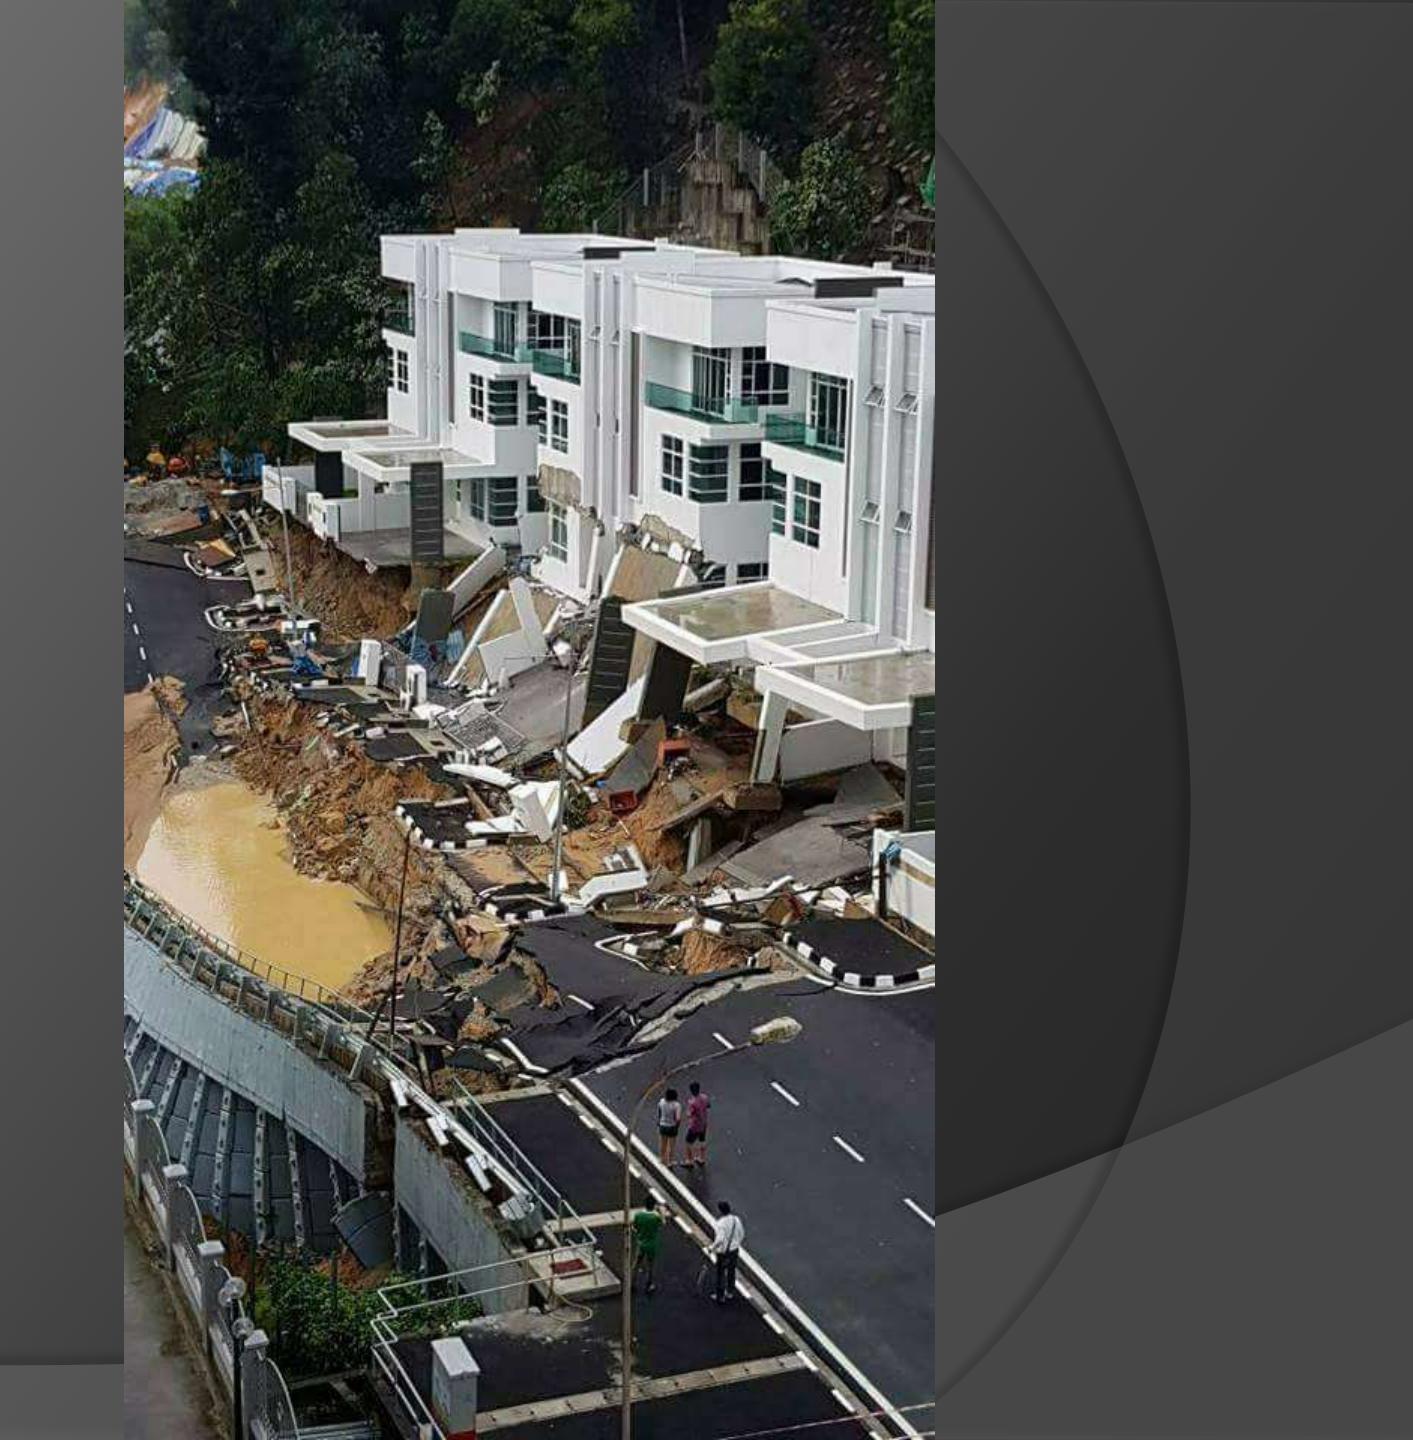
The failure of this retaining wall is due to global stability and not local stability of the design. Most time during submission, many councils forget about the global stability which have around five criteria to be fulfilled.

From these photos, the slippage of reinforcement is due to slip circle. In this case the initial breached would be the base or foundation for this type of retaining which is likely to be a shallow foundation. The design most likely only considers the overburden and rely the strength of anchors to withstand lateral load.

In reality, the slip circle formed behind these anchors (assuming with the length up to the end of the carriageway close to the building). The slip circle formed when water table increased (unsure if its due to subsoil or surface drainage but it is likely due to insufficient interceptor drains around the perimeter with rock bolt or soil nail behind the building).

To make it easier to shift is the drain in front of the retaining wall and tangent to the slip circle which start to saturates the soil around the foundation of the retaining wall. When breached, the retaining structure will overturn or slide forward. In this case, engineer should have prescribed the use of piles or raking piles as countermeasure against moment developed from surcharge and lateral force if there is no space to provide rock toe for the retaining wall. Nevertheless, it is only good if the local stability of the system allows rigid connection (resisting moment) between foundation to the system in event of slip or wedging occurs behind anchors.

Part of the building (car porch) sheared since the column is sitting on pad footing. The rest of the structure is in tact due to the strong and shallow distance between pile cap to the rock socket. Since the pile is not slender, it is sturdy and robust to withstand movement of the soil.

The soil reinforced wall is not suitable and shall not be use for any construction around the sensitive area.

In the future, the only soil retaining structures allowed for such construction shall be the conventional retaining wall or T-Wall (with key) and sit on piles which able to cut off the water flow net and slip circle and to reduced possibility of sliding, overturning or even if there is a change on the soil bearing or condition/state.
